Creating an Anticipatory Management Plan for Carneros Creek, Napa CA

Master of Landscape Architecture

University of California, Berkeley

Spring 2010

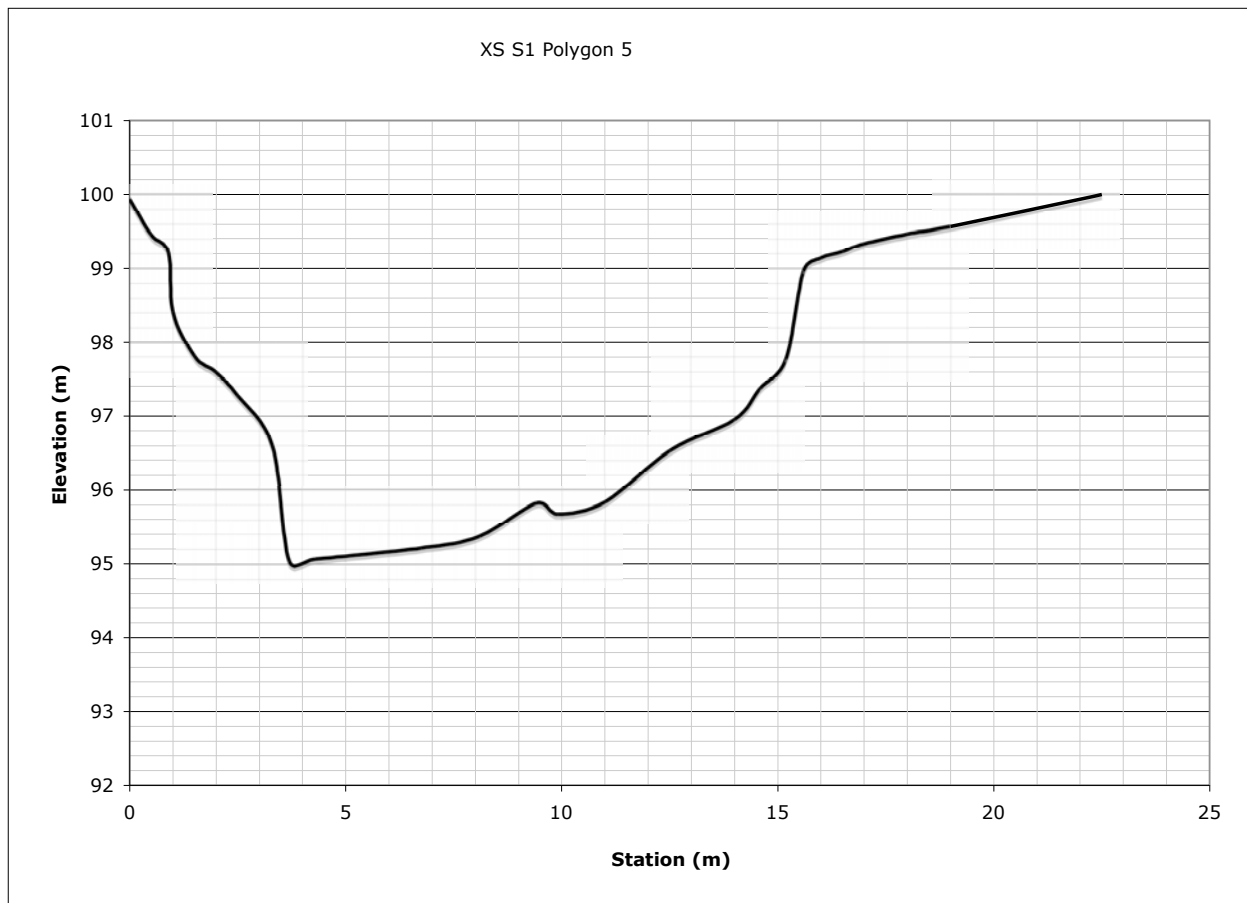
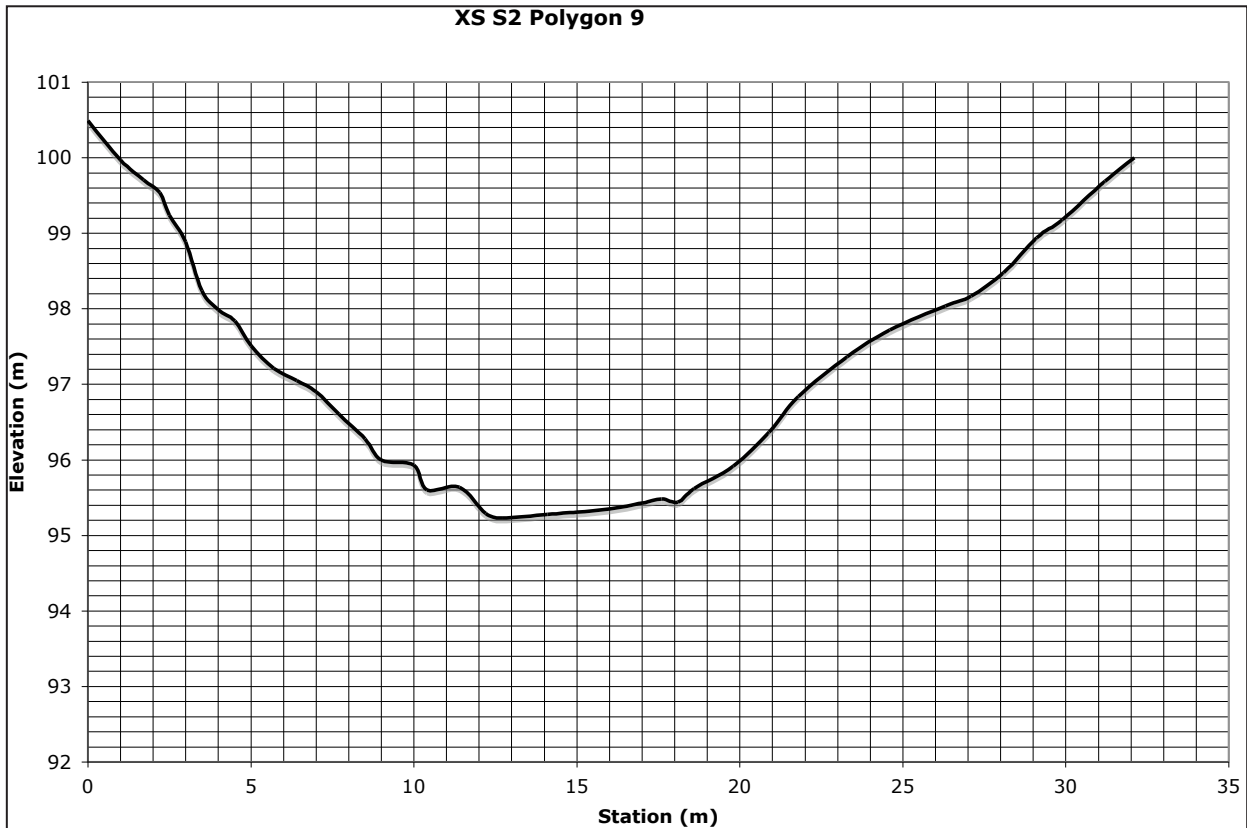
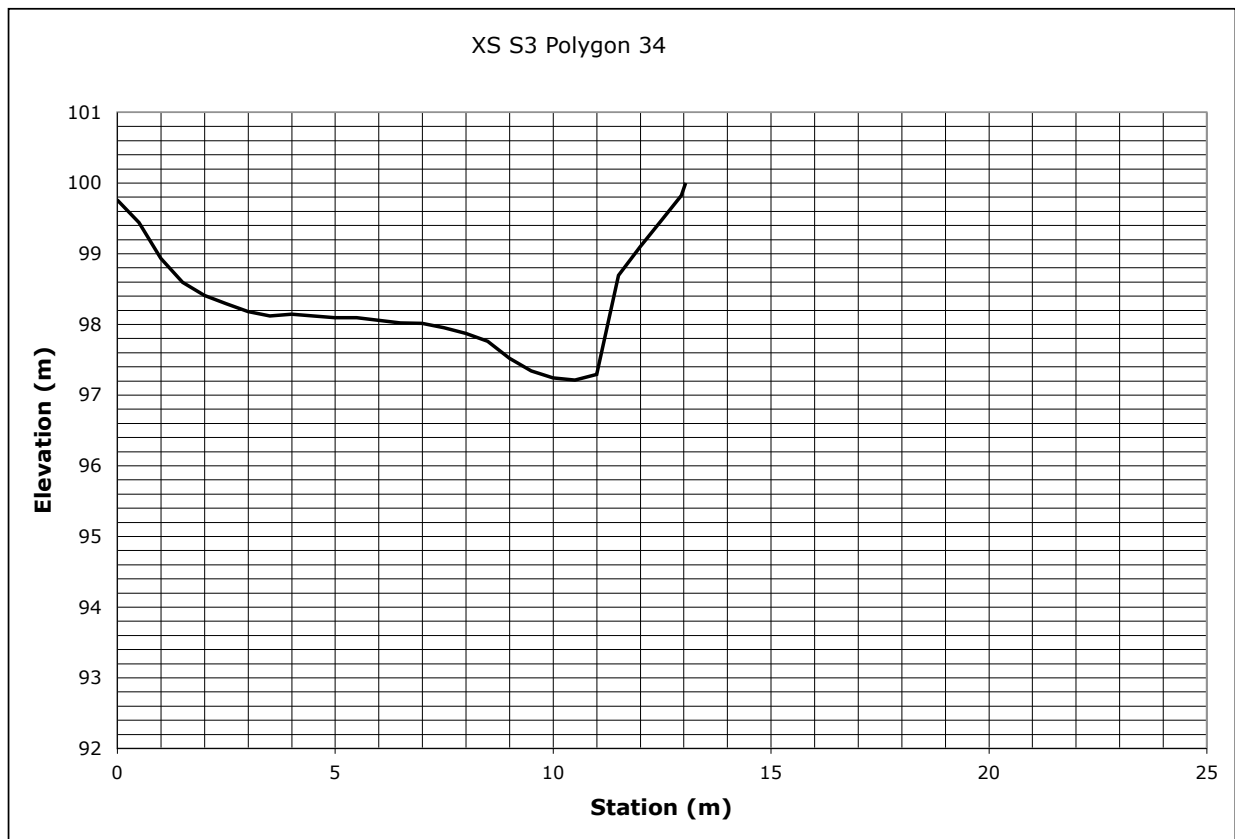
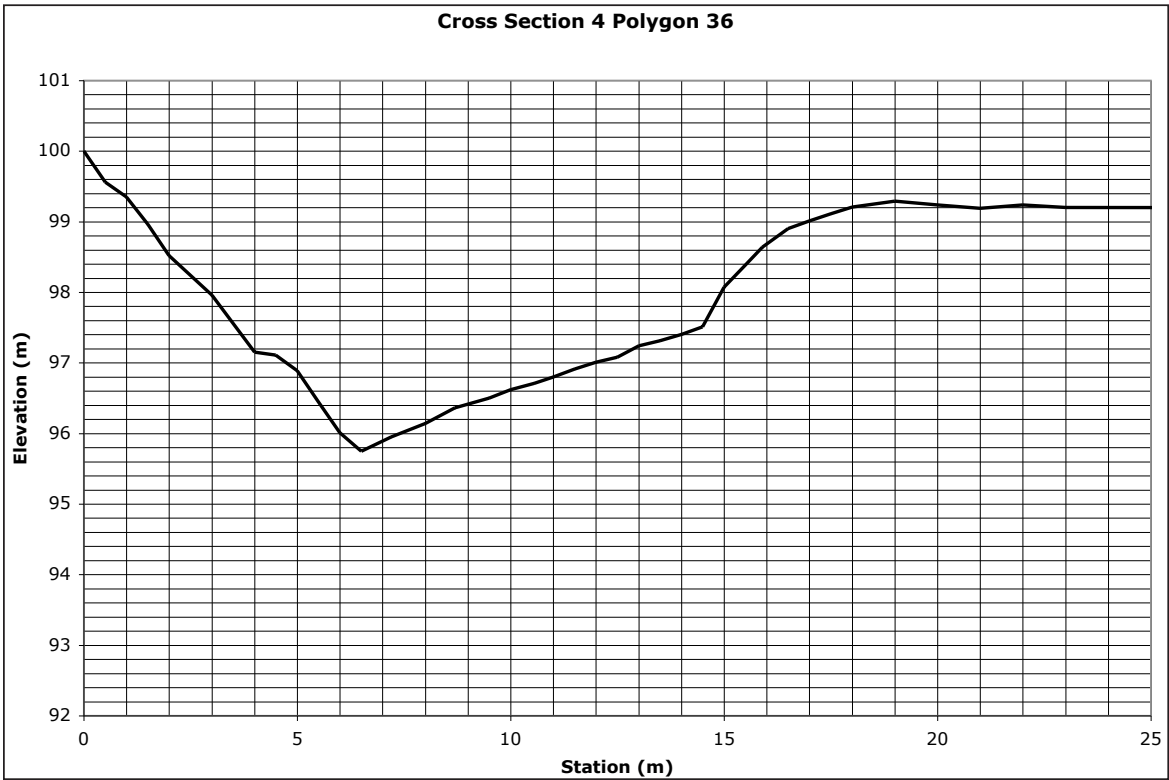
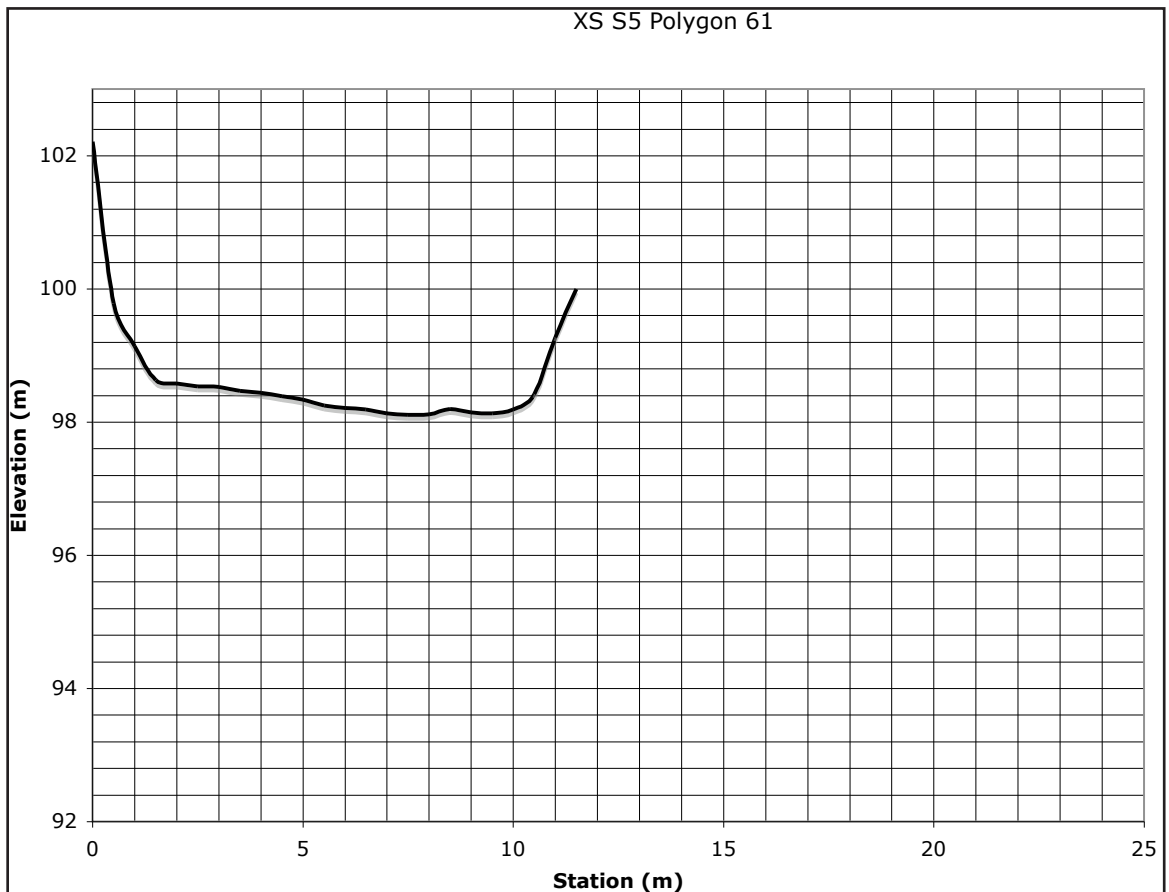
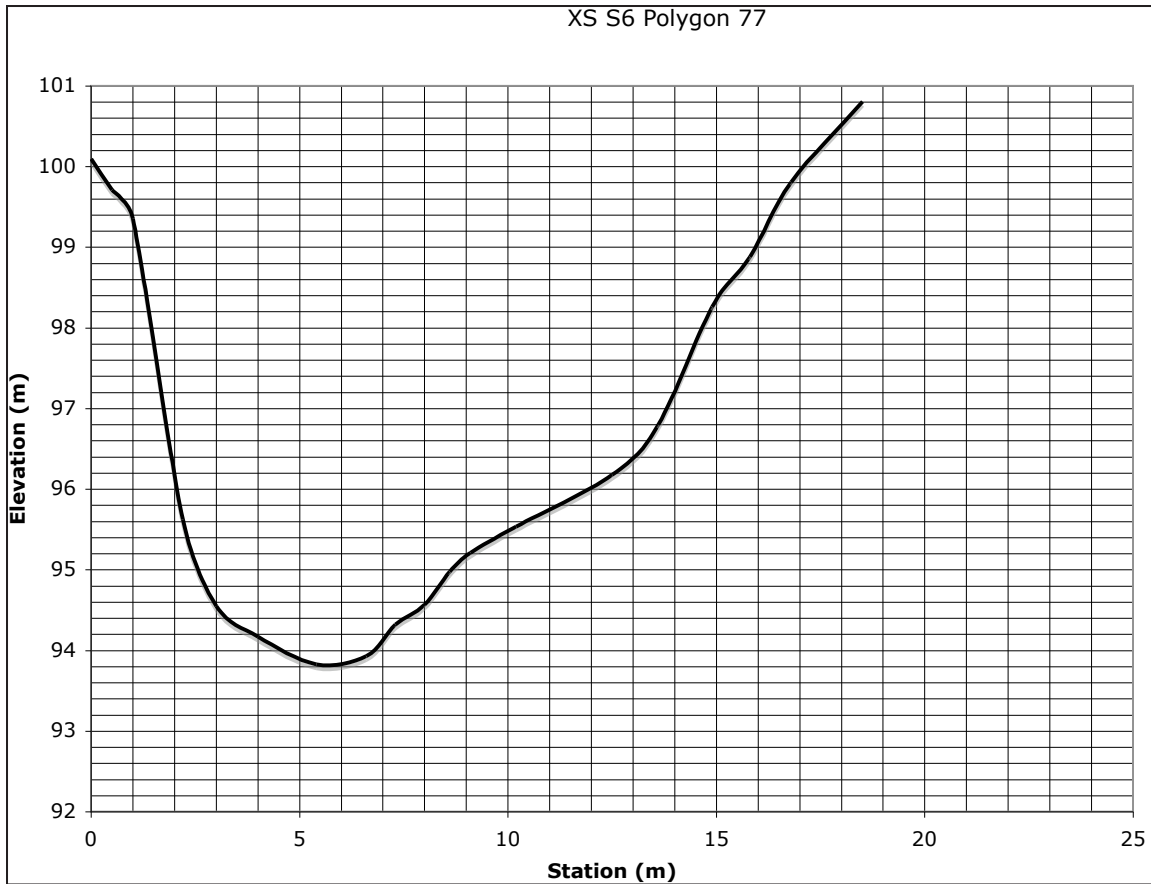
## Appendix A | Cross Sections Summer 2009

The following nine cross sections were surveyed in July, 2009. They are distributed approximately by property (almost two per property), and were chosen to be representative of the varying geometries of the creek channel. The right and left bank pins are monumented with rebar and GPS coordinates are recorded. Long profiles and pebble counts are available on request. I started at the most downstream end with cross section 1; cross section 9 is the most upstream location.
